ASX-1000 Series Drip Cup Control Rod Spring Replacement

To replace a worn or broken drip cup control rod spring and or washer, perform the following steps:

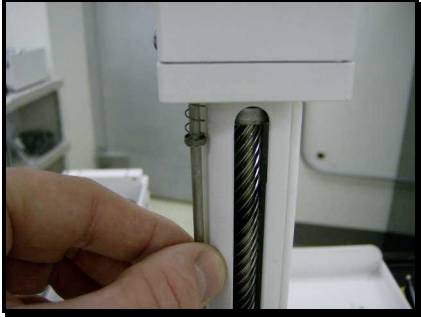
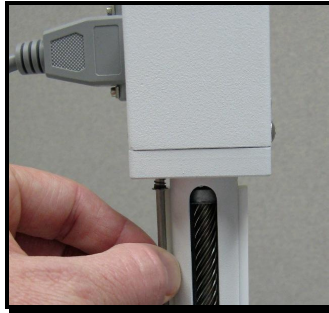
Fig. 1 Old

1. Remove drip cup.
2. Slide the z-axis probe block down to the lower end of it's travel.
3. Lift up on the control rod, which has the faulty spring. Fig. 1.

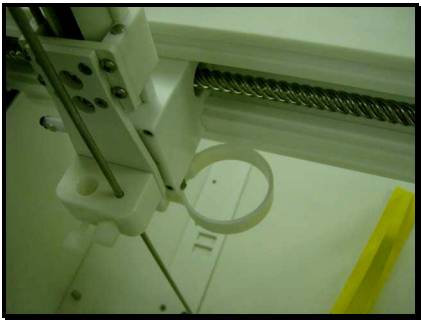
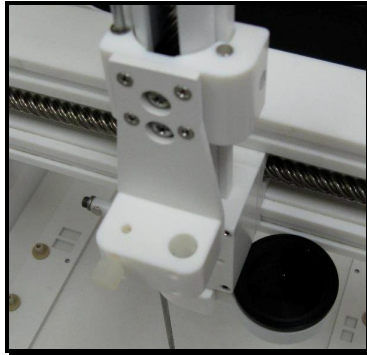
Fig. 2 Old

4. Rotate the drip cup holder past its normal rotation, toward the y-arm. Fig.2.

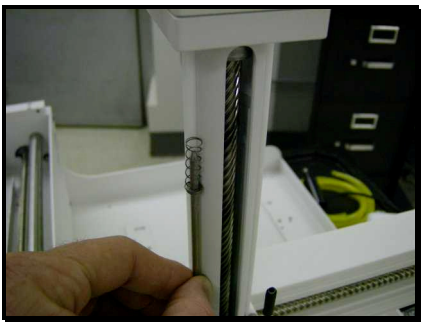
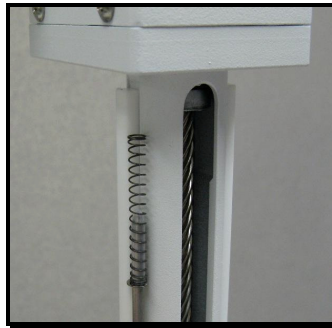
Fig. 3 Old

5. Lower the control rod and replace the spring and washer. Fig. 3.

6. Replace the control rod by pushing the control rod up to maximum physical position into the motor mount housing. This ensures clearance for the drip cup cam to rotate back into position. Rotate the drip cup holder back into position and release the control rod, the rod should rest into the channel of the drip cup cam. Replace drip cup.
7. Slide probe block up and down several times to ensure the control rod and drip cup operation is correct.
